# Argonne National Laboratory

## INSPECTION, EVALUATION, AND OPERATION OF THE EBWR REACTOR VESSEL

November 1965

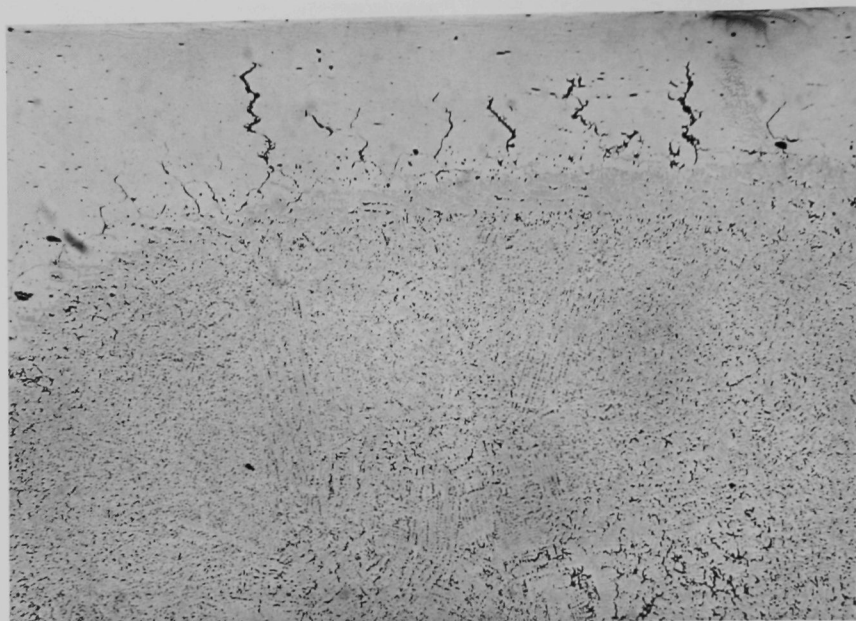
Fig. 11. Cracks Radiating from the Weld Kernel

A thin zone of the cladding, approximately 0.001 in. thick, was found to be carburized in the bonded zone at the weld nuggets. No barrier was used to prevent the migration of carbon during the cladding process.

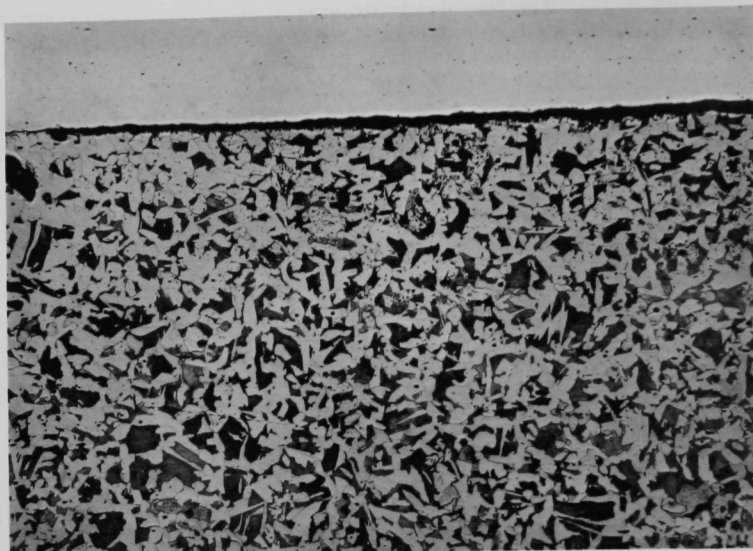
(10) In the bond region, the SA-212-B vessel steel was decarburized to a depth of 0.010 in. max (see Figs. 15 and 16), and the SS Type 304 was carburized to a depth of approximately 0.001 in. (see Figs. 15 and 20).

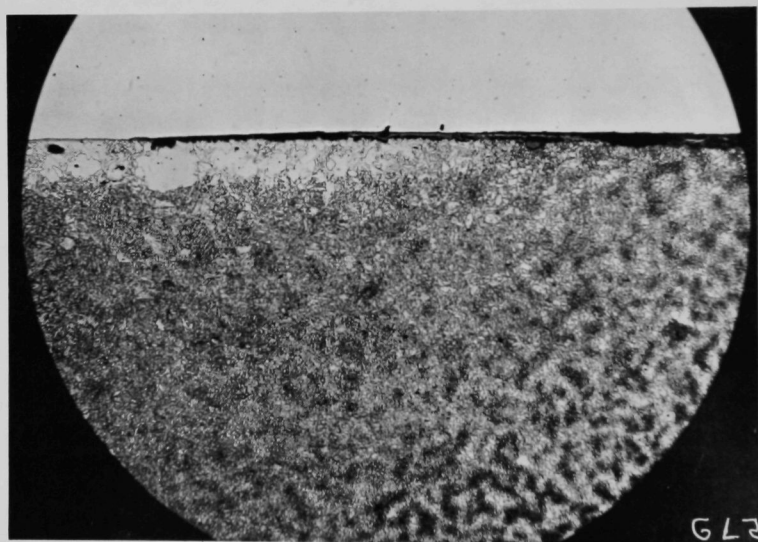
(9) In the bond region, the SA-212-B vessel steel was heated by the welding current (without melting) to the austenitizing temperature, quenched *in situ* by conduction into the interior of the carbon steel plate, and subsequently tempered. The transformed structure in the SA-212-B bonded area is shown in Figs. 14, 16, and 22.

Fig. 21. Typical Micro Structure of SA-212-B Plate from Reactor Vessel

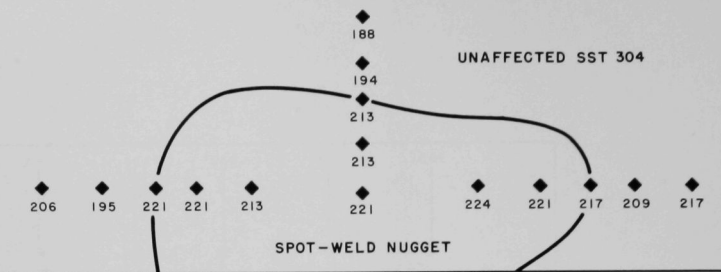
Microhardness surveys on the stainless-steel cladding and the SA-212-B steel of the pressure-vessel-boat samples were locally affected by the migration of carbon across the bond zone. The hardening of the stainless-steel cladding or the softening of the SA-212-B steel is not significant as far as the propagation of cracks or the strength of the vessel is concerned. Results of the hardness survey of both metals are summarized in Figs. 23, 24, and 25.

Fig. 25. Hardness Survey of Weld Nugget Area (DPH)

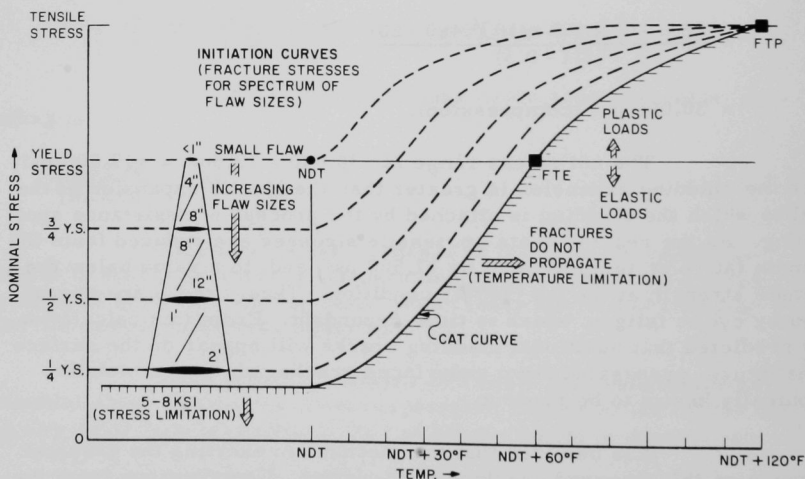
It has been shown that the  $NDT^{5a}$  (nilductility temperature) of the plate used for this vessel is about  $80^{\circ}F$ . On this basis, the FTP (fracture transition, plastic) of this material is  $200^{\circ}F$  and the FTE (fracture transition, elastic) is  $140^{\circ}F$ . Figure 27 indicates<sup>6</sup> that, at  $NDT + 60^{\circ}F$ , a crack 2 ft long stressed at the yield strength will not propagate.

Fig. 27. Generalized Fracture-analysis Diagram, as Referenced by  $NDT$  Temperature

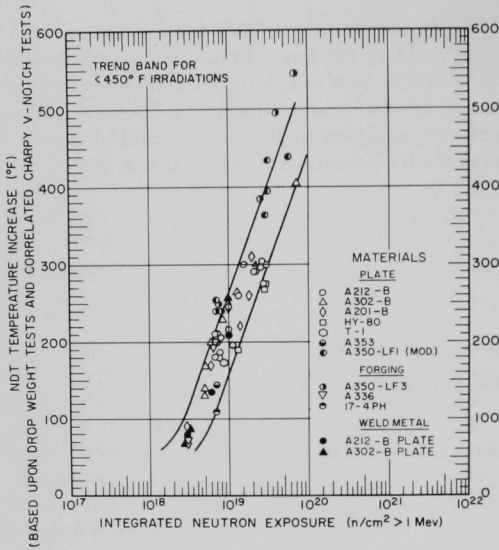
Also considered was the effect of irradiation on NDT. It is estimated that the maximum nvt  $>1$  MeV to which any part of the EBWR vessel has been exposed is  $8.65 \times 10^{17}$ , and the projected nvt  $>1$  MeV for 80 MW-yr (the maximum anticipated during the Plutonium Recycle Program) is  $<3 \times 10^{18}$ . It has been shown, and it is accepted generally, that there is an insignificant effect of irradiation on NDT of SA-212-B steel resulting from exposure of nvt  $>1$  MeV up to  $10^{18}$ . Figures 28 and 29 indicate<sup>7</sup> that, at nvt  $>1$  MeV =  $3 \times 10^{18}$ , the NDT increases about  $150^\circ\text{F}$ , which would result in FTE of 290 or  $200^\circ\text{F}$  below operating temperature of EBWR. This subject is discussed in more detail in Appendix B of the "Safety Analysis Associated with the Plutonium Recycle Experiment in EBWR."<sup>8</sup>

Fig. 28  
Increase in NDT Temperatures of Steels  
Resulting from Irradiation at Tempera-  
tures below 450°F

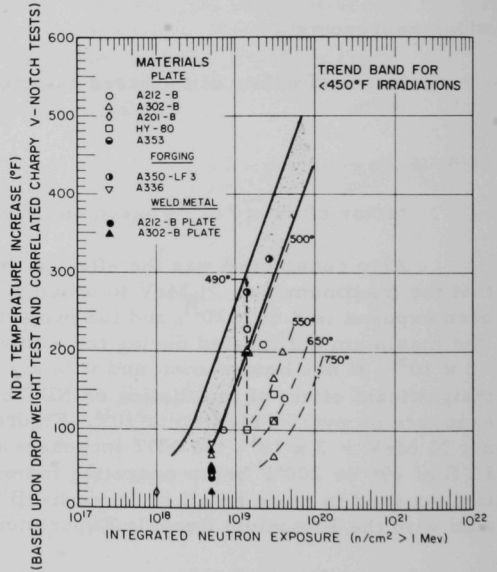
Fig. 29  
Increase in NDT Temperatures of Steels  
Resulting from Irradiation at Tempera-  
tures above 450°F. Points at  $5 \times 10^{18}$  n/  
cm² represent early irradiations in the  
Brookhaven Graphite Reactor at 500 to  
600°F.
